RENOVATION OF SHAFT MINING BUILDING NO. 2 IN KŁODAWA SALT MINE

Tomasz BŁASZCZYŃSKI¹, Przemysław WIELENTEJCZYK²

Poznan University of Technology,
Institute of Structural Engineering, Poznan, Poland

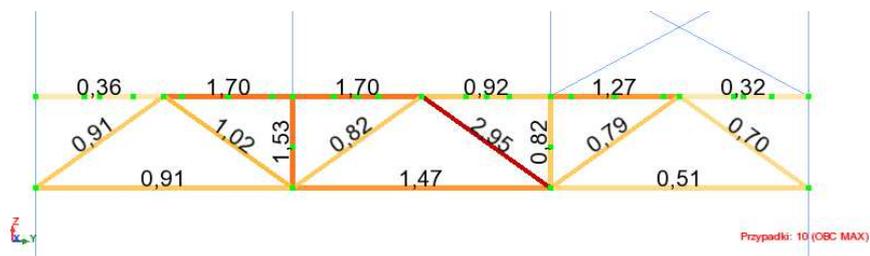
In order to demonstrate the durability analysis procedure and accepting necessary reinforcement on its basis, sample calculations of the load-bearing lattice in axis 3 below the level of +5.30 m have been presented in this chapter. This is a very important element of the construction, as it carries the loads of many higher floors. The calculations were carried out in the Autodesk Robot Structural Analysis program. The spatial model has been presented in Fig. 2. Figure 4 presents the level at which the lattice bars are used, accounting for 30% weakening due to corrosion (state determined on the basis of studies). A coefficient of 1 indicates 100% use. As indicated, the stress-strain state of most profiles in the central zone of the girder significantly exceeds the permissible limits. It should be recognized that a beam with a use of 2.95 was improperly selected at the initial design stage of the construction or that the technological load increased over the time the building was in service. Fig. 5 shows the stress-strain state of the elements of the lattice accounting for strengthening. Examples of how the profiles can be strengthened have been presented in pt. 5.

Fig. 4. Stress-strain state of lattice in axis 3 with profiles weakened by corrosion

The lattice under the level of +5.30 m in axis 3, due to the high stress-strain state of the bars and progression of corrosion, was strengthened by fitting cross braces and additional angle sections adding a minimum of 50% to the cross-section of strengthened bars. The connection of the lattice beam to the existing studs was additionally strengthened by constructing a table under the lower strip. Attention was given to maintaining the continuity of the added angle brackets in the upper and lower strips of the lattice girder. The angle brackets were connected outside the joints on full butt welds.

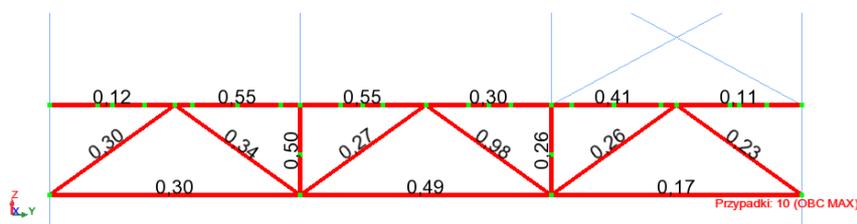
Fig. 5. Stress-strain state of lattice in axis "3" following strengthening
