BIODETERIORATION DUE TO IMPROPER EXPLOITATION OF EXTERNAL FACADES

Marlena PIONTEK¹, Hanna LECHÓW
University of Zielona Góra, Poland

Keywords: facades, buildings, facade exploitation, biodeterioration, deposits, stains

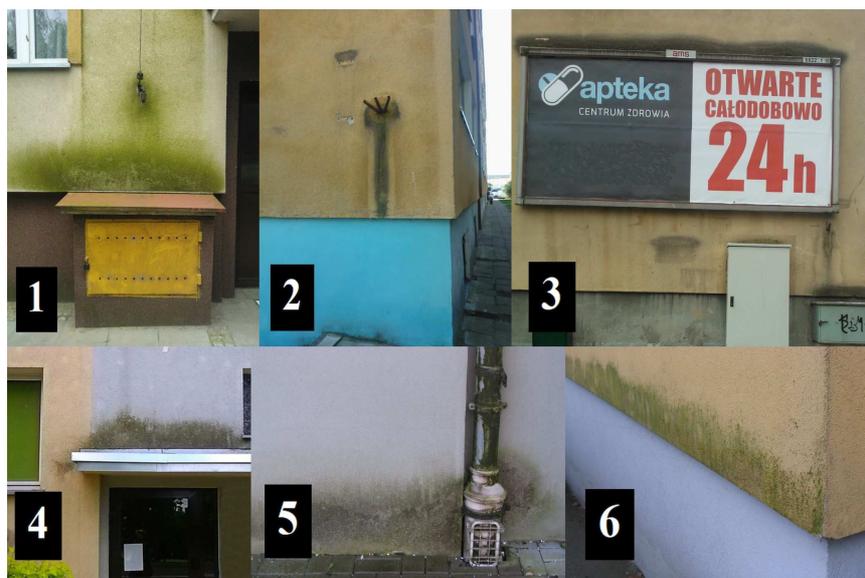
Fig. 1. View (1-6) on places in northern facades with visible discoloration and deposits

The phenomenon is caused by moisture which persists with higher intensity than in other parts of the facade and is the main factor contributing to the formation of biological corrosion [3, 4, 6, 8-11]. Over time, it can lead to the formation of biodeterioration (biological corrosion). With the increase of water content within the material, its coefficient of thermal conductivity grows as well, thus

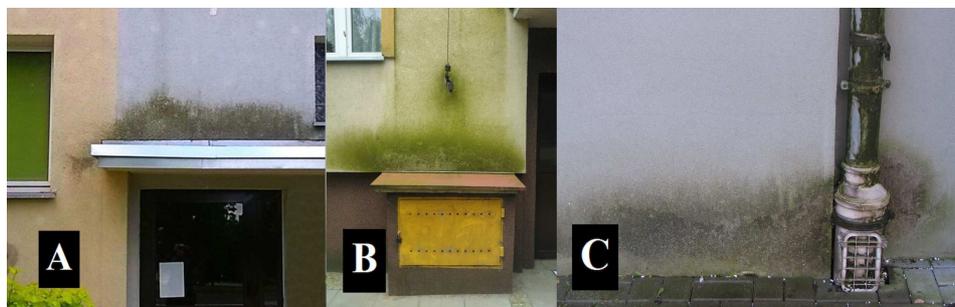
Fig. 2. View of the sampling areas on the northern facades of buildings in Zielona Góra: A- multifamily building developed at Podgórna Street, B - multifamily building developed at Batorego Street, C- facade of the buildings of the Environment Engineering Institute of the University of Zielona Góra.

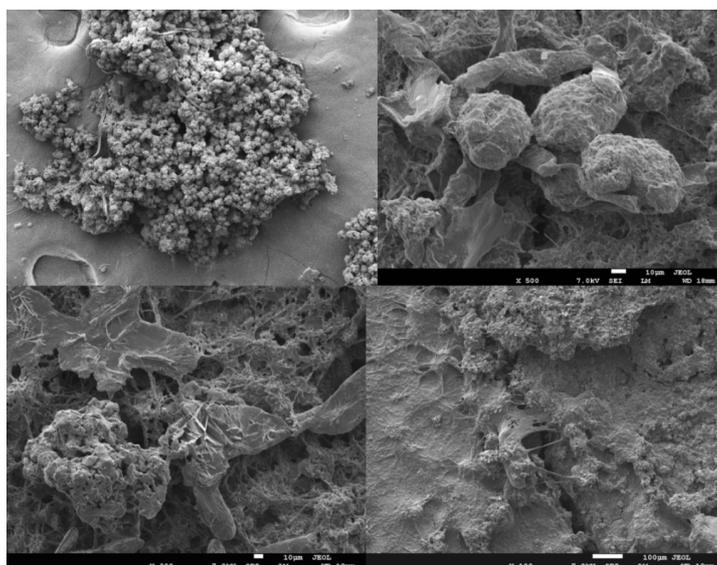
SEM photos showed (Fig. 3) the presence of biological agents in deposits found on the facades. Their presence results in the emergence of unsightly deposits and formation of degradation processes. Photos made with the use of the nanometer technology revealed the complex structure of the deposits.

Fig.3. Exemplary SEM photos of the biological material collected from northern elevations of buildings with deposits
