# Civil and Environmental Engineering Reports

<b>Tomasz BŁASZCZYŃSKI, Przemysław WIELENTEJCZYK, Maciej BŁASZCZYŃSKI, Filip PIJANOWSKI</b> RENOVATION AND MODERNISATION OF A POSTINDUSTRIAL FACILITY IN POZNAŃ .....	5
<b>Jakub CZARNECKI</b> REVITALISATION ISSUES OF SETTLEMENTS BUILT IN 1946 – 1974 IN TERMS OF SOCIAL AND DEMOGRAPHIC CHANGES .....	19
<b>Dariusz GAWEŁ</b> REBIRTH OF POSTIDUSTRIAL ARCHITECTURE IN POLISH TOWNS .....	31
<b>Renata GNATOWSKA</b> APPLICATION OF MODEL METHODS IN DESIGNING AND MODERNIZATION OF BUILT-UP AREAS .....	41
<b>Anna KOSSAK-JAGODZIŃSKA</b> THE ASSESSMENT OF THE QUALITY OF PUBLIC SPACE ON THE EXAMPLE OF KATOWICE AND BYTOM .....	51
<b>Paweł MARYŃCZUK</b> COMPOSITION OF A PLAN OF AN ARCHITECTURAL COMPLEX .....	63
<b>Maria MRÓWCZYŃSKA</b> PREDICTION OF DEFLECTION FROM FLATNESS AND A VERTICAL POSITION WITH THE USE OF NEURAL NETWORKS .....	73
<b>Beata NOWOGOŃSKA</b> INTERDEPENDENCE OF BUILDING ELEMENTS IN THE ANALYSIS OF REPAIR .....	83

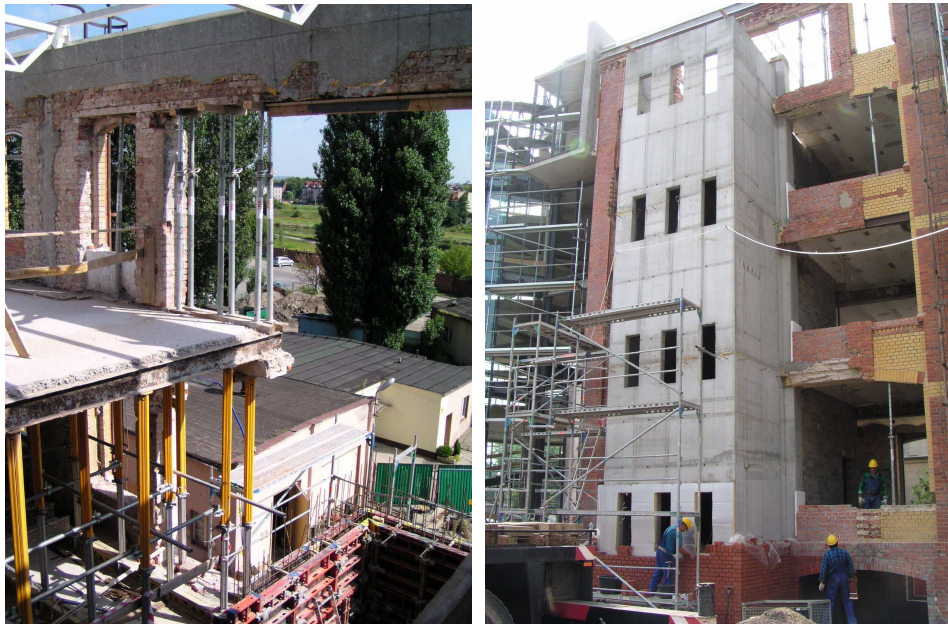
Fig. 16, 17. Restoration of the back staircase basing on SCC concrete

Due to the poor technical condition and safety risks of the back staircase (fig. 2), it had to be dismantled and reconstructed conforming to all the requirements of the building conservation officer (fig. 16, 17).

impossible to use a classical kind of concrete due to the poor technical condition of the existing building and the fact that various kinds of steel merged with each other (fig. 16, 17). Self compacting concrete provides tight filling of the boarding yet under its own weight, while maintaining high uniformity even if there is a dense reinforcement [11]. It is a unique product especially useful when vibrators cannot be applied, also in the case of erecting additions or expansion of existing facilities, particularly historic ones, and also when formed and reinforced steel merge with each other. On the basis of the formed superstructure, a three-layer wall was produced with an elevation layer made of specially selected face bricks.

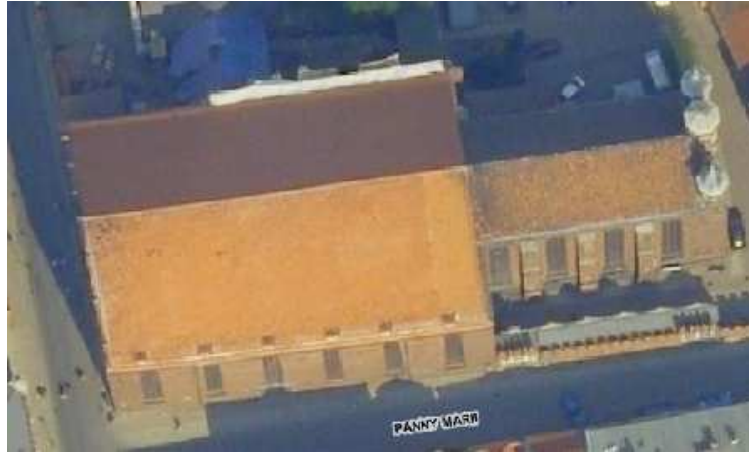
Fig. 2. Satellite picture of the Blessed Virgin Mary in Toruń

The surfaces of the object walls undergo a technical control during their erection and their exploitation (Czaja, 1983). The example utilises the measurements of the walls of the Blessed Virgin Mary church in Toruń, which were carried out with the use of the spatial angular indentation method. The walls neighbouring Virgin Mary's Street were subjected to a particularly thorough analysis (fig. 2 and fig. 3). The church erection was commenced at the end of the 13<sup>th</sup> century, and the works lasted about 150 years. The building was repeatedly modernised, and obtained its current shape after the renovations carried out after World War II. Nowadays, the church is a three-nave, asymmetrical building with an extended presbytery 27m high and 66m long. As a result of the building and modernisation works, particularly the alterations in the roof structure from a triple-pitched roof into a double-pitched one, the church's walls displayed considerable deformations from the flatness and the vertical position, which initiated the control measurements carried out in 1977 for the first time (Niepokólczycki, 1977, 1981) and in 2011 for the last time (Nagórski 2012).

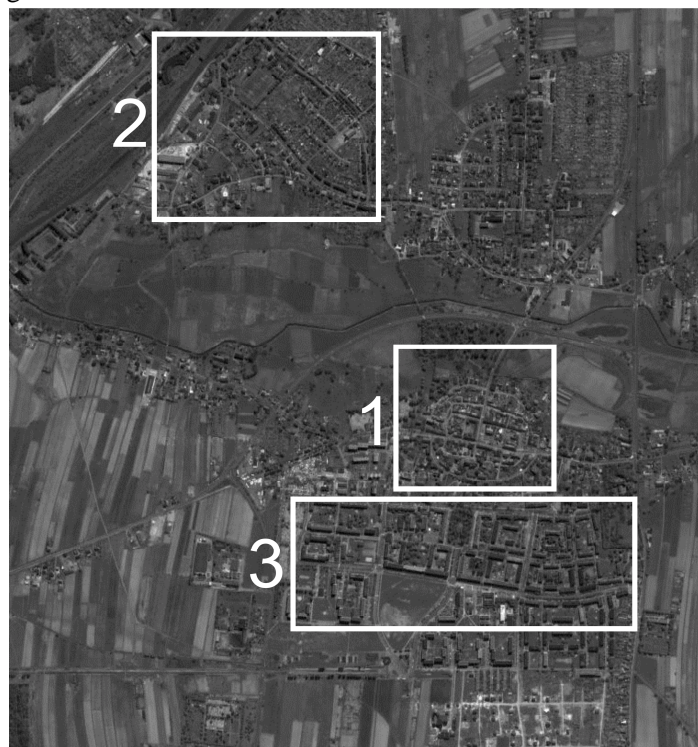
Fig. 1 Urban complexes in Pyskowice, 1 – the medieval system, 2 – the railway housing estate, 3 – the socialist-realism housing estate.

Three urban complexes were formed in Pyskowice over the centuries:

1. Primary connected with the location of the town in a traditional medieval system, in a form of rectangular quarters with an oval ring, a town hall at the centrally situated market. The system, in spite of the vicissitudes of fate, wars, and changes in the construction technology was restored by a

2. An estate complex for the railway workers, which developed together with the railways set up in 1879. It was essentially expanded when the railway junction was being built in the 30s, before the World War II.
3. A socialist-realism housing estate, built in connection with the planned vast industrial investment, the existing neighbouring factories and mines as a housing estate for their workers.

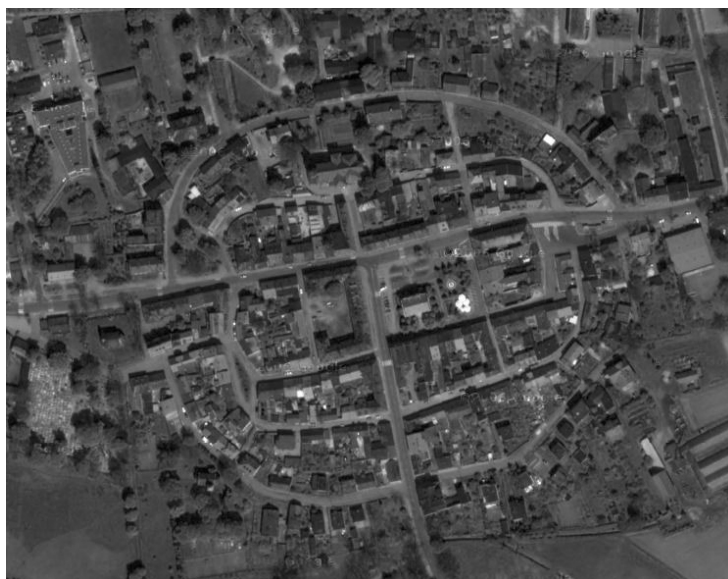
Fig. 3 The medieval street plan around the town hall.

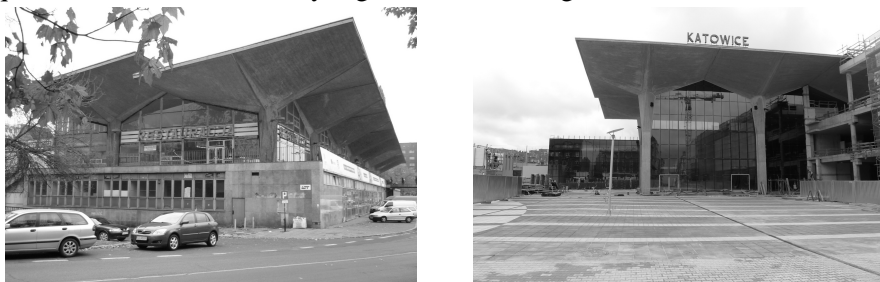
Fig. 1-2. The negating attitude - Katowice Railway Station, designer Waclaw Kłyszewski, George Mokrzyński, Eugeniusz Wierzbicki, Waclaw Zalewski, 1959 - 1972, state of 2010 (photo on the left), demolished in 2011, the renovation of a part of the “cone” structure in the “railway station gallery” - new shopping centre formed in place of the railway and bus stations, 2012 (photo on the right).

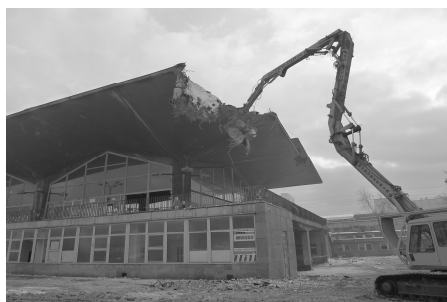
Fig. 3. The beginning of the demolition of the Railway Station in Katowice (photo by R. Nakonieczny 2010).

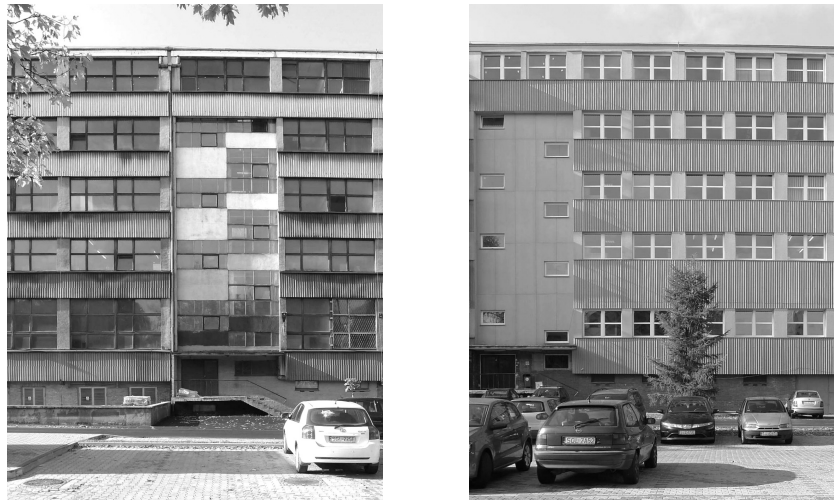
Fig. 5-6. The attitude of the partial acceptance - the Department of Civil Engineering Laboratory, Silesian University of Technology. Designed by Professor T. Teodorowicz-Todorowski (1973), Elevation before and after thermal insulation in 2012. Its project, completely obliterating the original features of the building, although obtaining a building permit, the attorney of the Academic District, Dr. G. Nawrot, protested thanks to which the building has partially retained some features characteristic for modernism. Unfortunately, the elevations have lost their original avant-garde character. Photo by R. Nakonieczny 2012.

7. **The legislation**, which creates conditions for negative transformation of objects. This is particularly true for thermal modernisations – based on the Act of 18 December 1998 on the support for thermal modernisations (Journal of Laws of 1998, No. 162), which in many cases extremely adversely affect the condition of the modernist heritage. This is due to the erroneous assumption that the energy balance of the building is seen in the act as a value superior to the cultural values of the modernised object. The Act imposes audit on the author of a construction project, as a mandatory guideline, which, in the absence of conservation protection, frequently results in devastation of stylistics and the designer acts on the edge of ethics and professionalism.

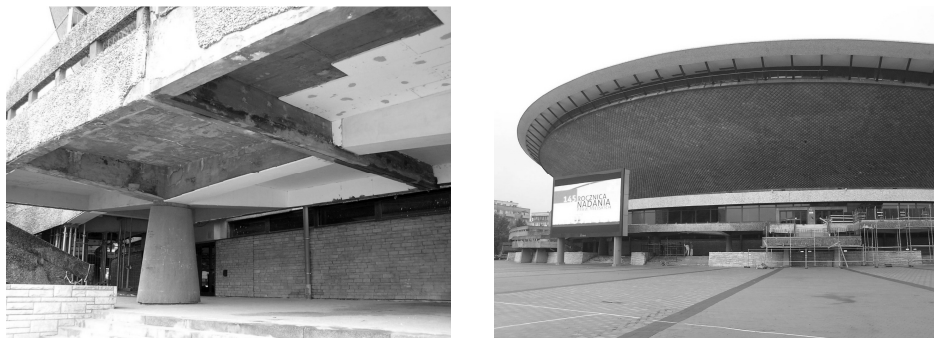
Fig. 7-8. The attitude of full acceptance – a sports hall "Spodek" in Katowice, designer M.Gintowt, M.Krasiński, A.Żórawski, A.Włodarz, W.Zalewski, 1960-1972. At the end of March 2011, modernization work was commenced (Figure on the left). The first project was commissioned by MOSiR and was rejected after the intervention of the Chamber of Architects and the provincial authorities who intended to favour projects which would preserve the historically well-established form of the building. In Figure on the left – the commence of the work, which resulted in protests – in this case: cladding the exterior terrace with a layer of polystyrene (!) designed in the „béton brut” aesthetics.

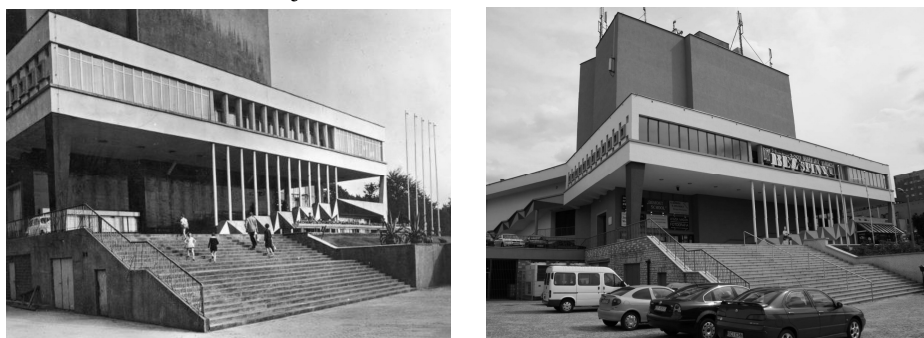
Fig. 9-10. The attitude of full acceptance – the theatre in Rybnik, designer J.Gottfried, H.Buszko and A.Franta, (1958-1964). State before and after modernisation in 2006 designed by J.Wawrzyniak. Full respect for the historical value of the object. The project included the preservation of a number of details such as the floors which retained their original form (i.e. broken slate floors) or Marian Rak's fresco adorning the entrance to the auditorium. Photo by R. Nakonieczny.

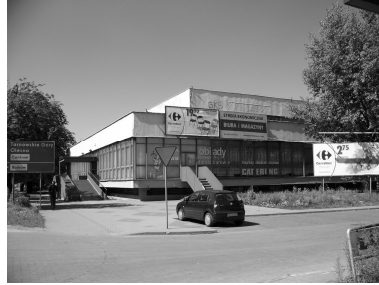
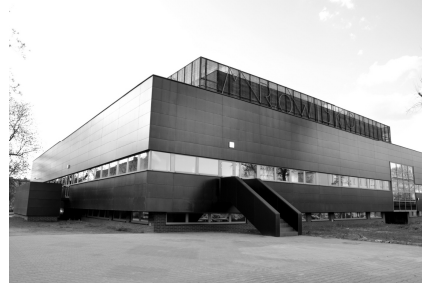
Fig. 11-12. The attitude of the creative continuation – adaptation of an academic canteen No. 2 in Pszczyńska Street into Student Cultural Center Mrowisko in Gliwice. A typical project by prof. T.Mańkowski and prof. K.Lenartowicz carried out in the 70s (the second object based on this project is located in Łużycka Street in Gliwice). 2010-2011 – reconstruction of the Cultural Centre, according to the design by prof. J.Witeczek and T.Wagner. The state before (2005) and reconstructed (2011)

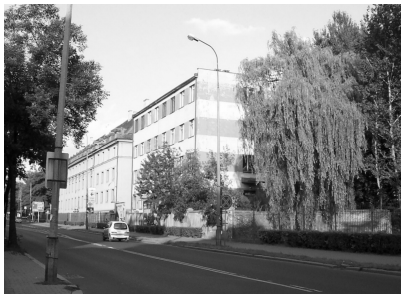
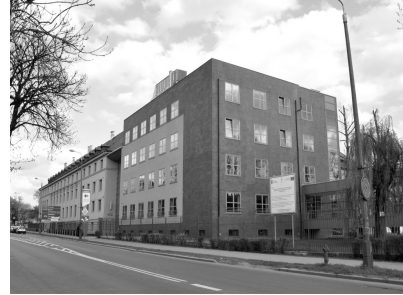
Fig. 13-14. The attitude of creative continuation – the reconstruction and extension of the Department of Organization and Management at Roosevelta Street 32 in Zabrze (former Military Command Replenishment). The design of the building sygn.1973 WBP, reconstruction 2006-2011, the authors of the project J.Witeczek, G.Nawrot, T.Wagner. The state before (2005) and reconstructed (2011)<sup>II</sup>.

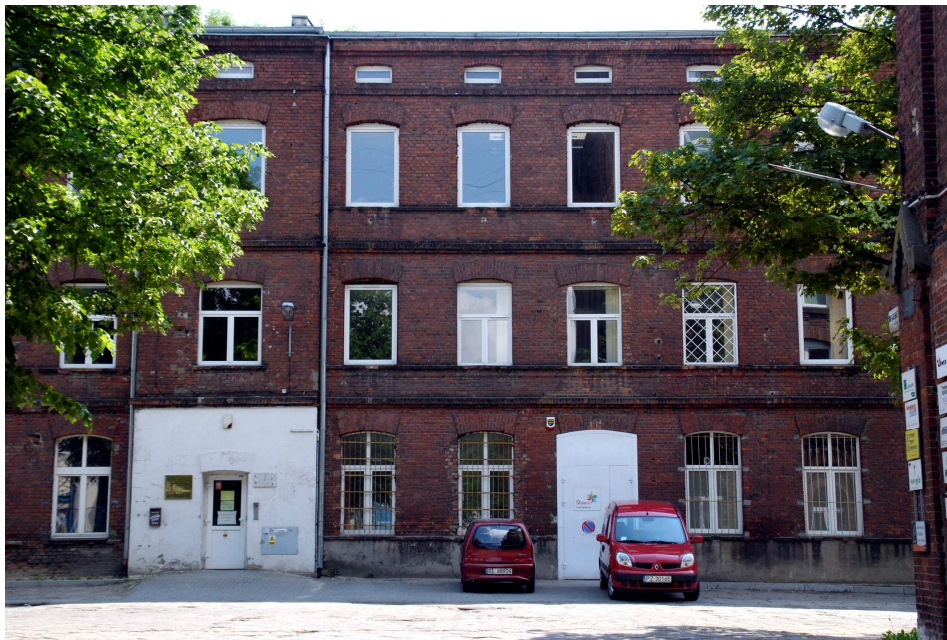
Fig. 4. An example of a building where an uncontrolled replacement of window frames led to the complete loss of the original aesthetics. Photo A. Kurzac

The windows are elements which are particularly vulnerable to destruction and ill-treatment. They are easy to be removed and commonly believed to be impossible to be properly repaired. Thus, this view results in the historic windows end up massively in landfills. When a building is adapted to the new functions, it is usually expected to meet the new standards of thermal and acoustic insulation - the fate of existing windows almost in advance is doomed.

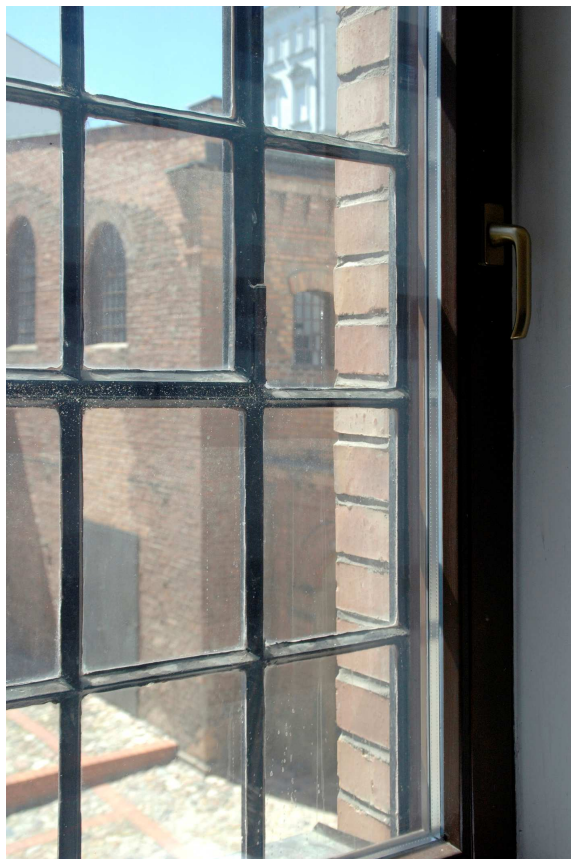
Fig. 5. Example of the installation of an additional window. Ludwig Geyer's "Biała Fabryka" (now Central Museum of Textiles), Łódź. Photo by A. Kurzac.

The original window may be left *in situ*, even if its technical condition forecloses its repair, through preserving an external window and the installation of an additional internal division. If the window survived to the present day in good condition, it is even better, because we receive a double protection from the weather.

There is a possibility of supplying the window with additional glazing along the perimeter of the window wings or doubling the number of wings, or finally, the installation of the additional glazing of the whole window opening from the inside or also providing an additional contemporary window. In many cases, introducing an additional glass sheet is a cheap, workable, and much more appropriate alternative to the installation of closed double-glazed units. It may be removed, allowing the original window to operate normally. It also solves the problem of heat losses and air streams passing through the leakage at the edges of the glass. Unfortunately, an additional glass sheet is not a popular option in Poland. The installation of an additional glass is merely an auxiliary, which may not be sufficient when the original window is in poor condition, but if connected with the renovation and repair, the results may be surprisingly good.

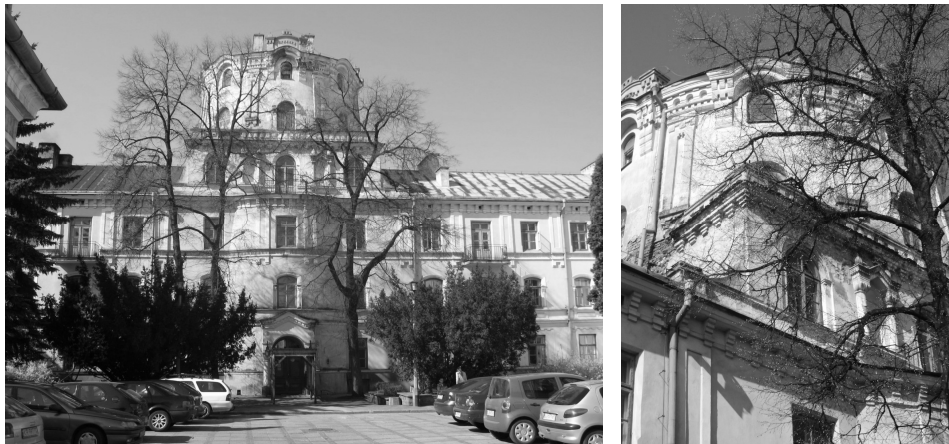
Fig. 1. A general view of the Palace – the current condition (2008). Photo by J. Wrana.

After the restoration works, in 1884, the palace gained its eclectic appearance which preserved till today. The recent elevation works were performed in 1986, since than no repairs have been carried out, hence the condition of the elevation is critical – numerous cracks are visible as well as plaster losses (or its complete lack, as in the case of north elevation), moisture, stains from leaking flashings. The elevation also poses a threat to users due to the fragments of the plaster which break away. Thus, it was necessary to build a

provisional canopy over the entrance protecting against a possible threat. Also, window frames (box windows) and the doors are in bad shape - clear distortions and leakage are visible.

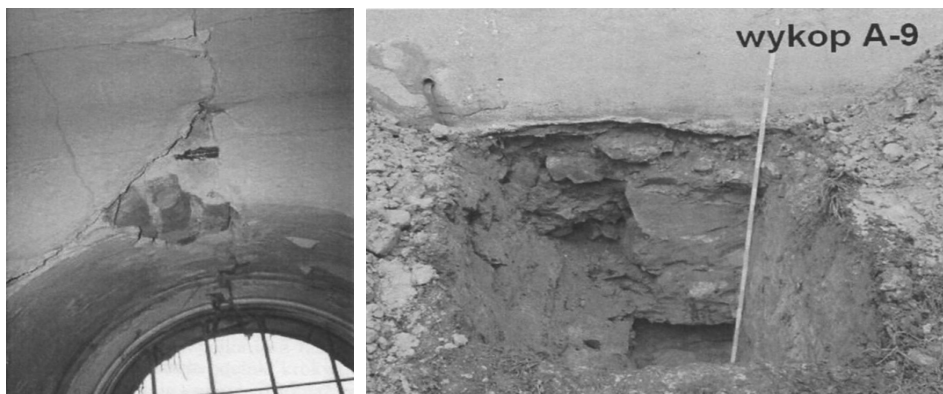
Fig. 3. Lintel with a visible crack exposing the reinforcing steel, 5<sup>th</sup> floor (tower) [4].

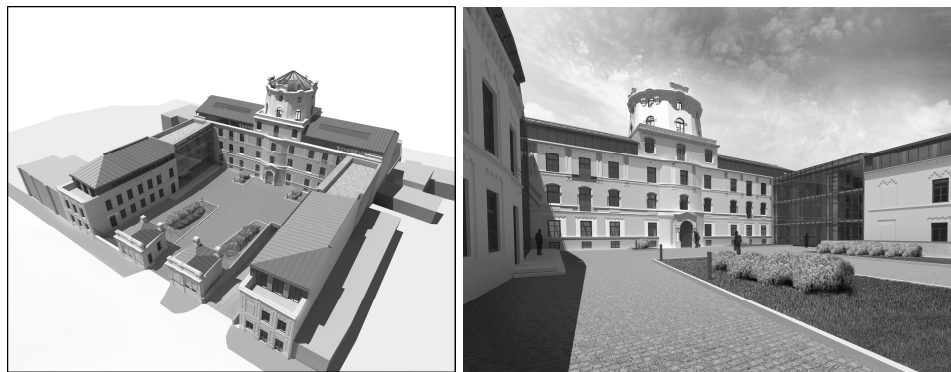
Fig. 5, 6. Visualizations of the modernization project of the Sobieski Palace: general view, courtyard. Computer imaging – prof. A. Getter's team (after the project implementation).

The project assumed a conversion of the existing main building and two collateral outbuildings, while merging the space through the addition of new objects (connectors). The formal assumption to the object shaping was to preserve all important elements, due to their conservation values, in the existent building, and simultaneously supplementing the building with new elements. To exhibit the architectural form and the rich ornamentation of historic buildings, all new buildings have a very simple and modest architecture with modern details; therefore, a passage between the existing outbuildings and the main building was designed in a form of a plane of glass façade, divisions of which refer to the levels of the existing cornices. Additionally, the application of these passages between the existing objects clearly depicts the axis of symmetry, emphasizing the dialogue between the past and the present.

The mentioned above passages are just the most interesting new elements together with the car parks and the auditorium which is submerged on an earthwork ground (on the escarpment opposite to the entrance courtyard), in order not to destroy the proportions of the elevation of the main building. A sloping, concrete wall which hides the new facade refers to the existing escarpment and constitutes a kind of base for the historic building of the palace. Covering the walls with evergreen vines will make it fuse with the current green slope, making the auditorium – of significant overall dimensions – “disappear” visually.
