IDENTIFICATION OF BIOGENIC SULPHATE CORROSION OF CONCRETE IN SEWAGE TREATMENT PLANT SETTLING TANK WALLS

Łukasz KRYSIAK¹, Paweł FALACIŃSKI, Łukasz SZAREK
Warsaw University of Technology, Warsaw, Poland

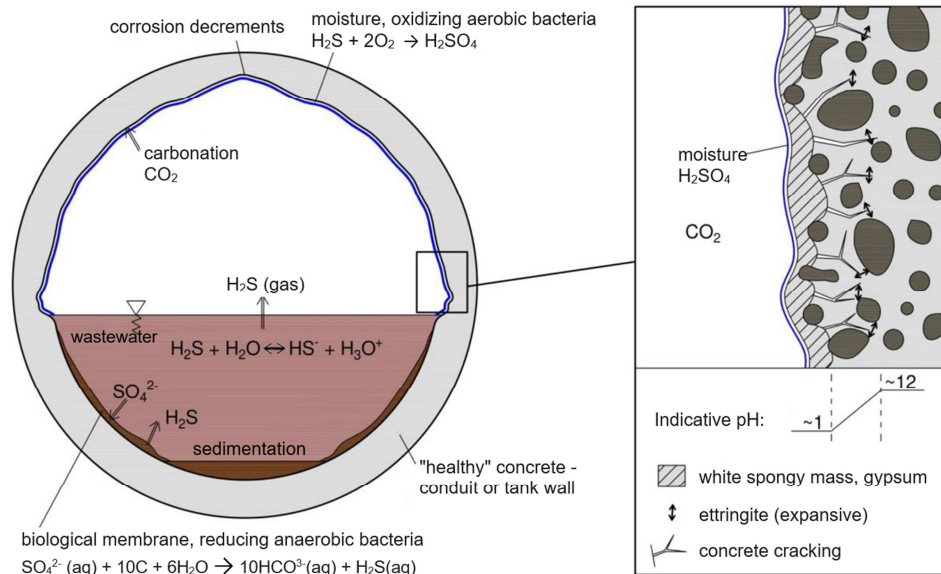
Fig. 1. Schematic representation of a BSC process in a concrete-walled sewage conduit or closed tank of a wastewater treatment plant. Developed based on [1, 3, 9, 20]

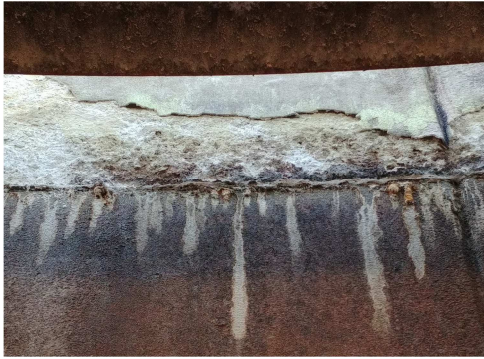
Fig. 2. Destroyed protective coating from the wastewater line upwards

The protective coating above the wastewater level was detached and partially destroyed, with yellow tarnish found on its remains, and a cream-white structure appeared on the exposed concrete surface. Local, very significant corrosion pits in the steel structures of auxiliary devices (sometimes through the plates) were also observed precisely at the wastewater table level – in the drainage flume and the radial scraper, most probably caused by the action of sulphuric acid (VI) near the surface of the wastewater. Examples of corrosive environment actions are shown in Fig. 2-7.

Below the wastewater table, the wall protective coatings, apart from local damage – osmotic bubbles, exhibited good adhesion to the substrate (Fig. 2). The bottom slab surface showed clear traces of mechanical abrasion, most probably resulting from the defective operation of the scraper, caused by breaking of the lines suspending the blade assembly. The coating was completely abraded in many places, with exposed aggregate (Fig. 7).

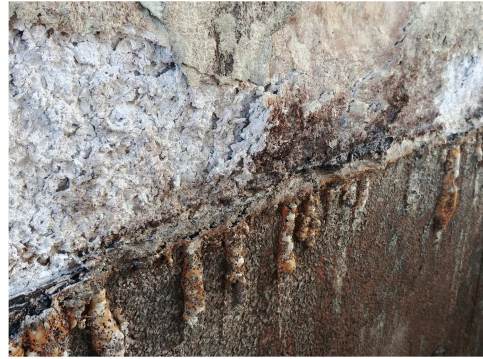
Fig. 3. Corroded concrete surface after detachment of the protective coating

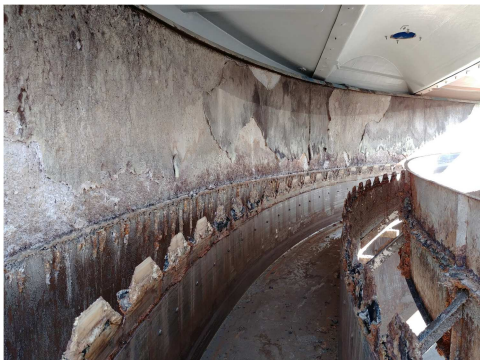
Fig. 4. Corrosion of the concrete wall (left) and the drainage flume overflow ridge steel

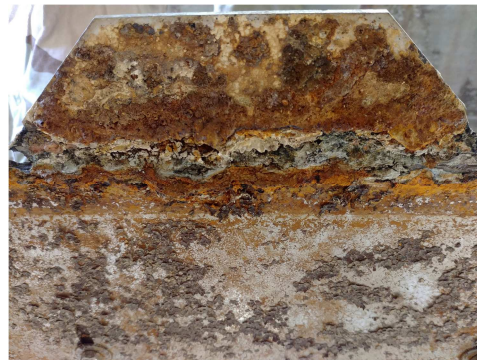
Fig. 5. Close-up onto a steel element of the drainage flume overflow ridge

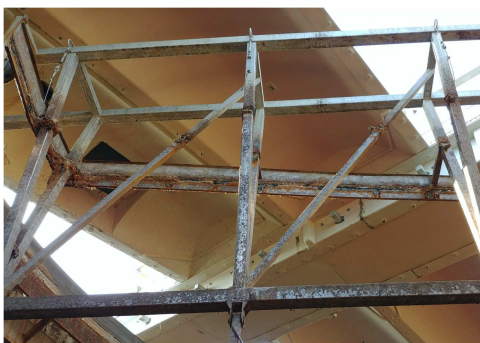
Fig. 6. Radial scraper lattice; visible strong concentration of steel element corrosion on the wastewater table level

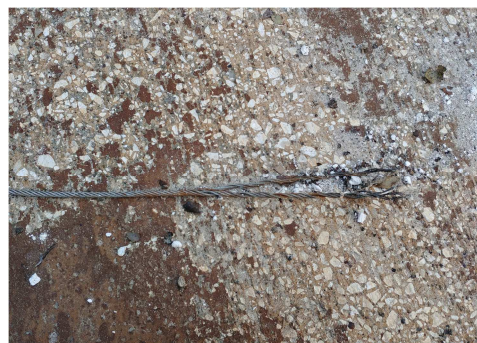
Fig. 7. Broken suspension line for radial scraper blades; aggregate in the bottom slab exposed as a result of excessive friction

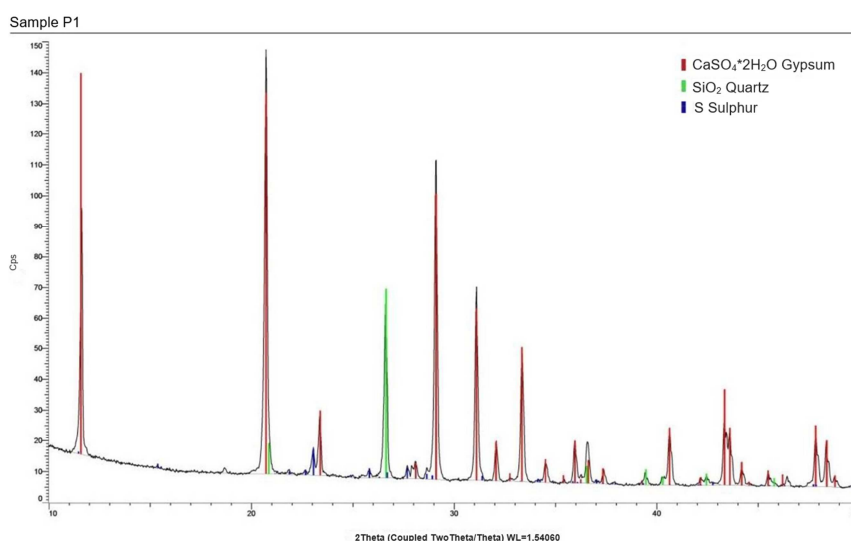
Fig. 8. P1 sample diffraction pattern

The image shown on the diffraction pattern, which contains the phases identified in sample P1 (Fig. 8), confirms the total destruction of the outer concrete cover. The resulting gypsum is the end product of sulphate corrosion. The P2 sample diffraction pattern image (Fig. 9) indicates phases occurring in the concrete, which has not yet been subjected to corrosion.

Testing with the use of X-ray diffraction analysis (XRD) were conducted at the Department of Inorganic Chemistry at the Faculty of Chemistry of the Warsaw University of Technology. The phase composition of the material was determined in two samples: P1 – concrete sampled from the outer layer (Fig. 8), with an appearance of a white spongy mass, and P2 – visually “healthy” concrete, constituting the direct cover of steel bars (Fig. 9).

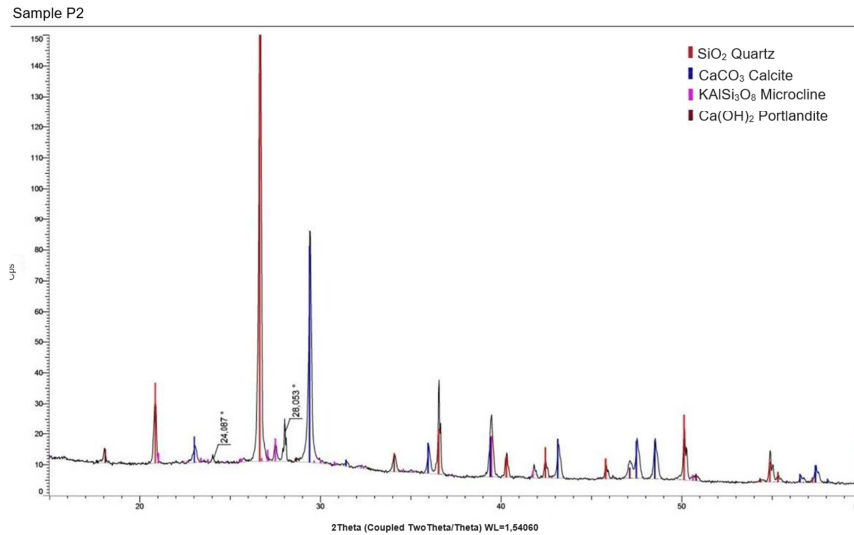
Fig. 9. P2 sample diffraction pattern

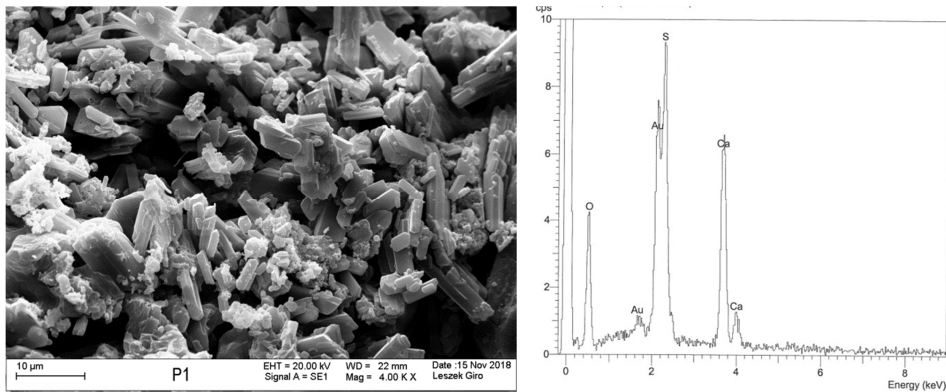
Fig. 10. Corroded concrete sample microstructure – sample P1

The results again showed that the outer concrete layer (approx. 3 cm thick from the wall face) was fully destroyed due to corrosion – resulting in the formation of crystallized gypsum (Fig. 11); part of the cover in direct vicinity of the re-bars did not exhibit any traces of sulphate corrosion (Fig. 11).

Tests using an electron microscope (SEM) with EDS analysis were conducted at the Micro-Area Analysis Laboratory of the Polish Geological Institute. This technique was used to determine the phase composition of the material in two samples: P1 (Fig. 10) and P2 (Fig. 11) (similarly to XRD).

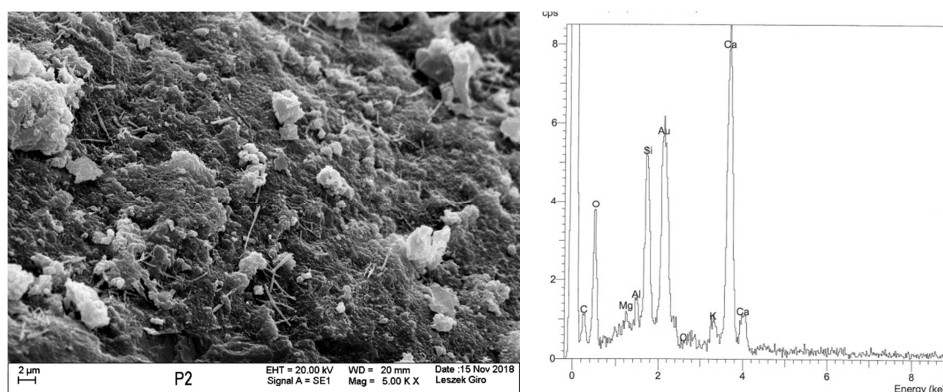
Fig. 11. “Healthy” concrete sample microstructure – sample P2
