DESIGN PROBLEMS WITH RENOVATING AND ADAPTING AN OLD MILL ON THE EXAMPLE OF THE EXECUTION OF AN ORIGINAL PROJECT

2. OLD MILL BUILDING IN ŁAZIEC

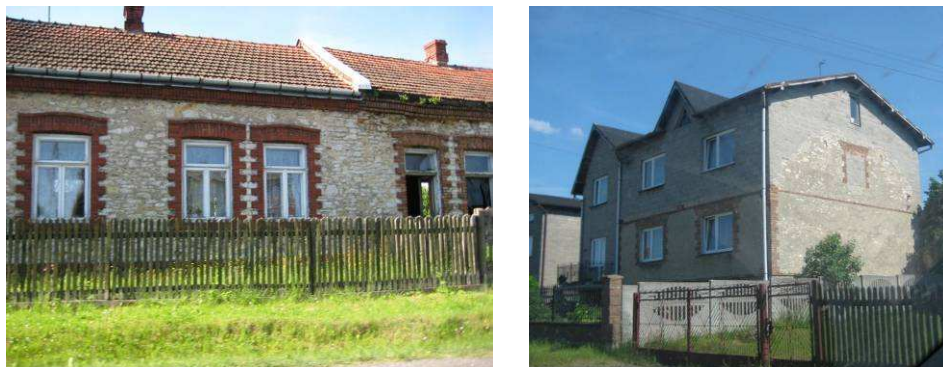
The building is located in Łaziec, in the gmina (municipality) of Konopiska near Częstochowa. This is an area where the Polish Jurassic Highland begins. A characteristic trait of the historical development found here are walls made of limestone, completed with brick elements. Bricks were used to construct the corners of the building and window openings, which resulted in the better bonding of the entire wall structures.

Photographs 3, 4. Existing buildings in the area of Łaziec,
(photograph by A. Grzonka 2011)

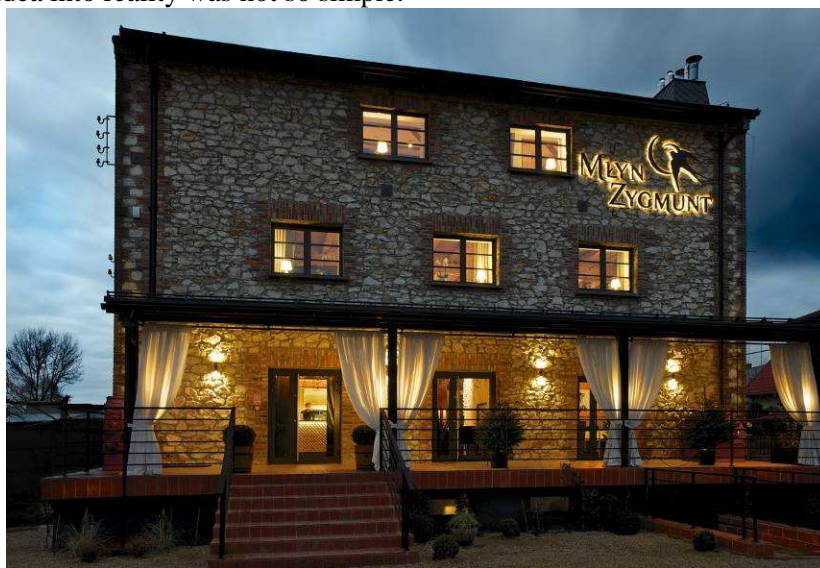
Photograph 5. Młyn Zygmunt Restaurant building following renovation,
(photograph by A. Nyk, 2014)

Before commencing work on the project, a technical inspection of the condition of the existing building was carried out. One of the problems which appeared was the issue of insulating the building, which was to be carried out. As a result of conservation and esthetic considerations, the most common and

recommended method of insulating buildings - from the outside, was rejected. Thermal insulation was carried out on the inside of the building. Initially, the insulation was to be made using purely mineral Epatherm climate boards manufactured by Epasit. Ultimately, however, for financial reasons, Ytong cinder blocks made of cellular concrete were used. Boards of mineral wool obtained from glass fibers characterized by the best heat transfer coefficient λ (lambda) and intended for carrying out thermal insulation on the inside of buildings were used as insulation.

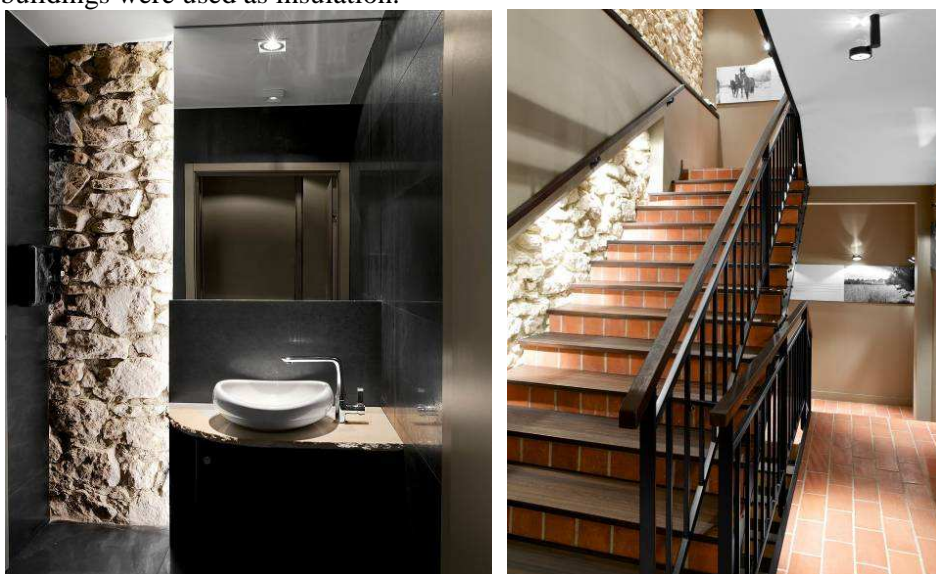
Photographs 6, 7. Młyn Zygmunt Restaurant following renovation,
(photograph by A. Nyk 2014)

The stone walls were subjected to renovation by replacing the mortar. The existing lime mortar had begun to crumble, which could have even led to the collapse of the building. In order to avoid such a situation, the decision was made to replace the existing mortar. This was no easy task. The works were carried out in phases on the entire building, including its interior. It was decided to use lime-cement mortar due to the beneficial qualities of lime. This substance has a positive effect on increasing the elasticity and adhesiveness of mortar to the surface. Along with the increase of lime in mortar, water vapor permeability increases, in addition to increased flexibility and the ability to self-heal minor damages. However, applying the new mortar posed the biggest problem. It could, on no account, be smoothed out, as this would have made the wall appear newly built.

In order to connect the exterior and interior of the building, a natural brick walls were exposed on the inside. By doing so, however, another problem arose - fulfilling the energy performance requirements of the building, which ought to be additionally carried out in order to obtain a building permit. This is why the surfaces of the exposed walls and their size are not random. Walls exposed on the inside were protected with a sealer to prevent the release of dust, and illuminated to emphasize their significance.

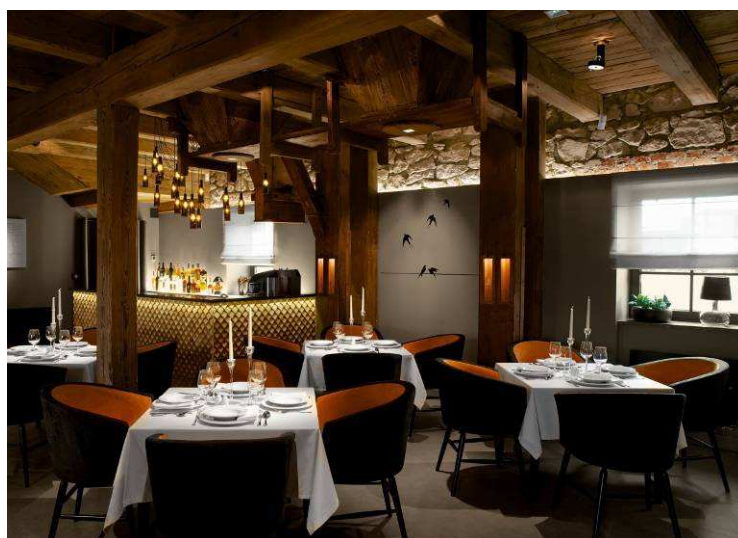
Photograph 8. Młyn Zygmunt Restaurant building following renovation, (photograph by A. Nyk 2014)

The biggest challenge for the architect, however, was adapting the building to fire safety regulations. The wooden structure of the building caused many problems. Initially, it was recommended that all wooden elements be covered, which was of course unthinkable from the esthetic point of view. The problem, was solved by applying a solution allowed by §2 of the Regulation of the Minister of Infrastructure on the technical specifications for buildings and their location [6]. As a result, a technical assessment of the state of fire safety for the reconstructed building with a changed service function was prepared, on the basis of which exceptions to the regulations were made.

The above made exceptions did not include the stairwell, which unconditionally had to be adapted to the specifications. The existing wooden stairs were taken apart and the opening in the ceiling structure enlarged to accommodate a full-sized stairwell. Landings and risers of the reinforced concrete stairwell were covered with original ceramic pantiles dating back to when the mill was first built. The pantiles were a recovered building material, acquired after taking apart a building and reused in the construction of another. The steps were made of oak wood, which had undergone ammonia fuming; this, among others, increased its durability. Because of the fact that the entire stairwell constitutes an element which was included in the existing building, it was decided to emphasize its distinctiveness. As a result, the space was used as a type of gallery, presenting the history of the mill and area in which it is located.
