INDICATING VERTICAL DEVIATION OF HISTORICAL BUILDINGS USING GEODETIC METHODS - CASE STUDY OF BRICK AND WOOD TOWER IN NOWE MIASTECZKO

Maria MRÓWCZYŃSKA¹, Sławomir GIBOWSKI²
University of Zielona Gora, Zielona Góra, Poland

Abstract

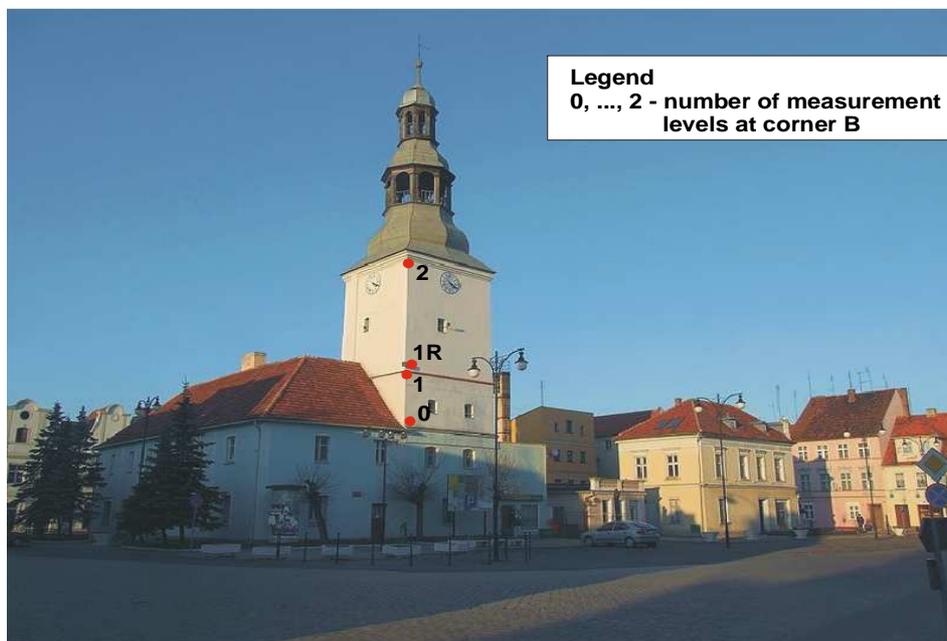
Measurement of vertical deviations by method of direct projection was carried out at 4 measurement points located at given levels of two corners (A and B) of the brick section - attention should be paid to the fact that one of the points (marked in Fig. 3 as 1R) was a reduction due to the change in the thickness of exterior walls, and at 4 measurement points located at given levels of two axes (E and F) running through the brick as well as wooden part of the tower (Fig. 4).

Fig. 3. Measurement levels on brick section of the tower
